INVENTORY OF MONUMENTS AT PAGAN

Volume One
Monuments 1-255

PIERRE PICHARD

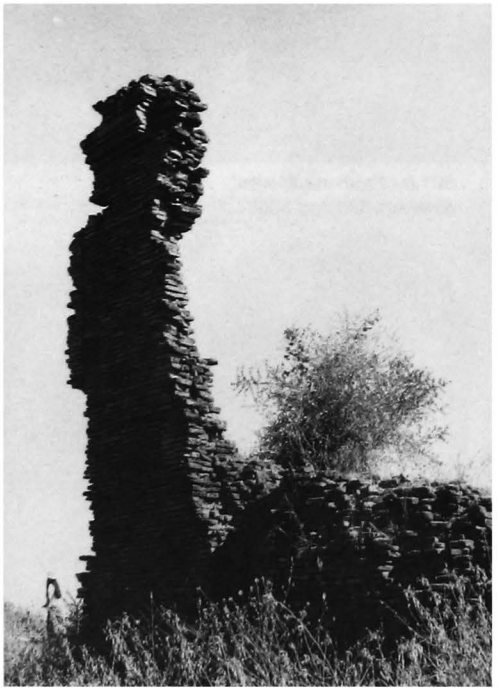
502 b - From south-west

5 present condition
- ruined.
- only north-west corner remains.
- ground floor buried under debris.

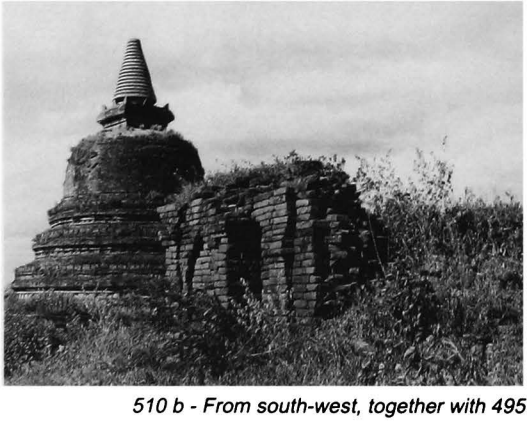
510 b - From south-west, together with 495

5 present condition
- ruined.
- only part of west wall remains.
- ground floor buried under debris.

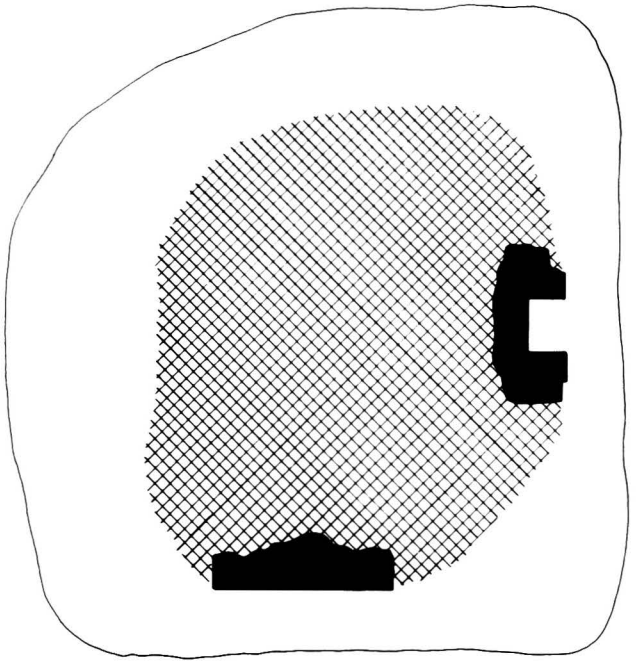
512 a - Plan

5 present condition
- ruined.
- only central part of east wall remains.
- ground floor buried under debris.

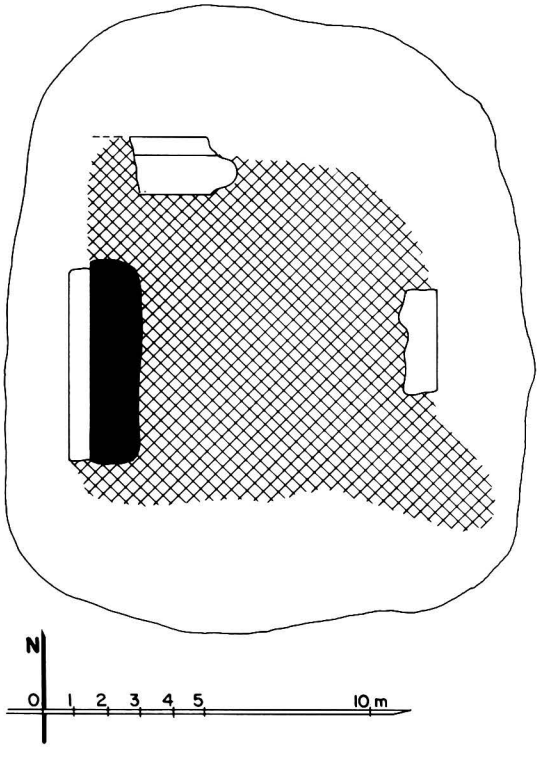
513 a - Plan

5 present condition
- ruined.
- only part of west wall remains.
- ground floor buried under debris.

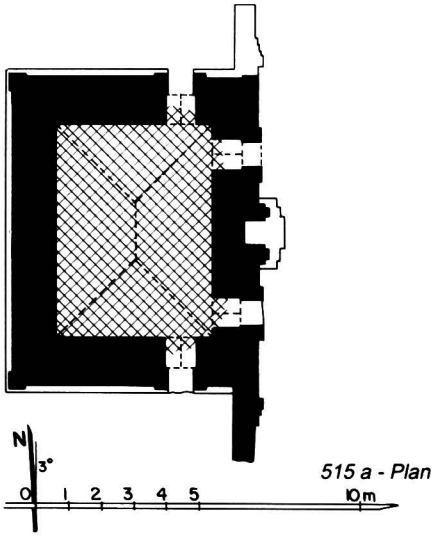
515 a - Plan

5 present condition
- half-ruined.
- vault and roof collapsed.
- ground floor buried under debris.

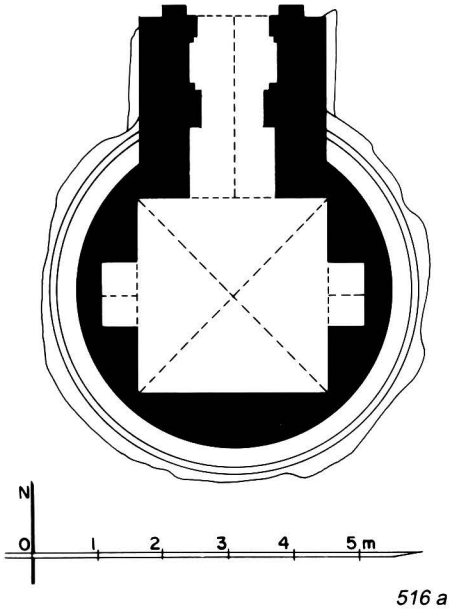
516 a - Plan

5 present condition
- no maintenance.
- base disintegrated.

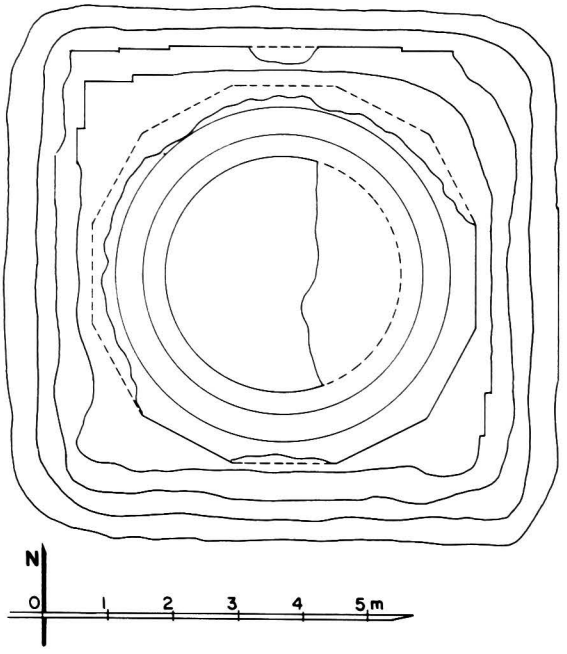
517 a - Plan

5 present condition
- no maintenance.
- base and terraces disintegrated.

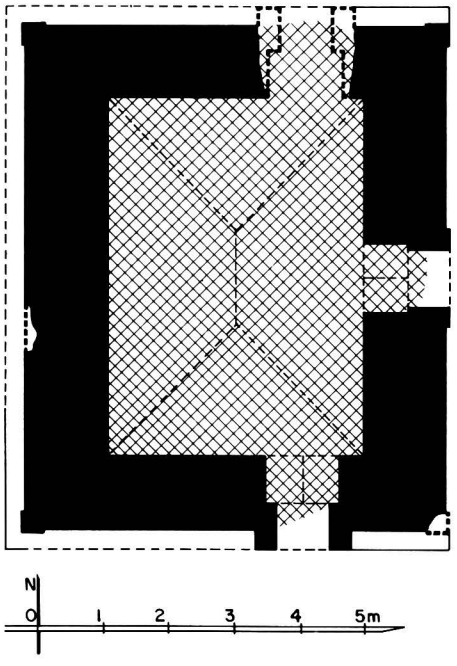
518 a - Plan

5 present condition
- ruined.
- vault and roof collapsed.
- ground floor buried under debris.

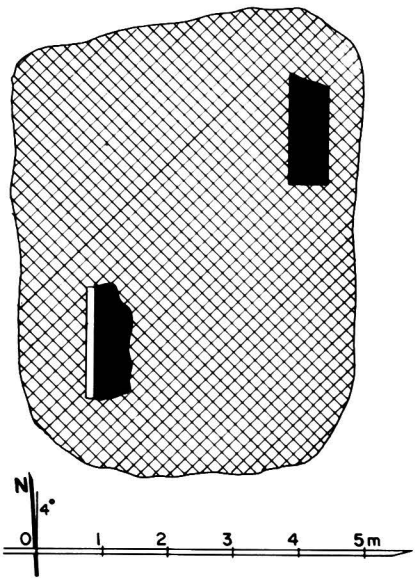
519 a - Plan

5 present condition
- ruined.
- ground floor buried under debris.

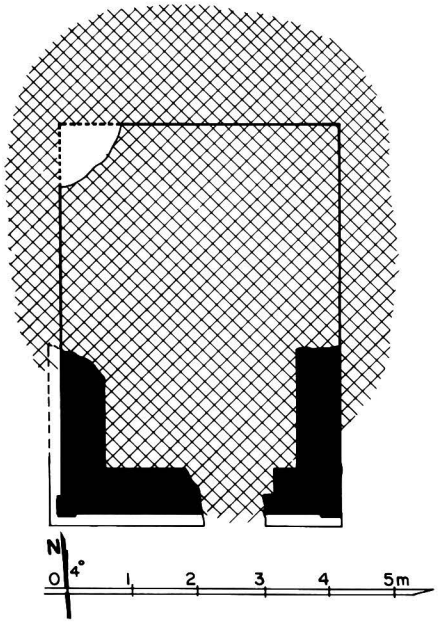
520 a - Plan

5 present condition
- ruined.
- only south part remains.
- ground floor buried under debris.

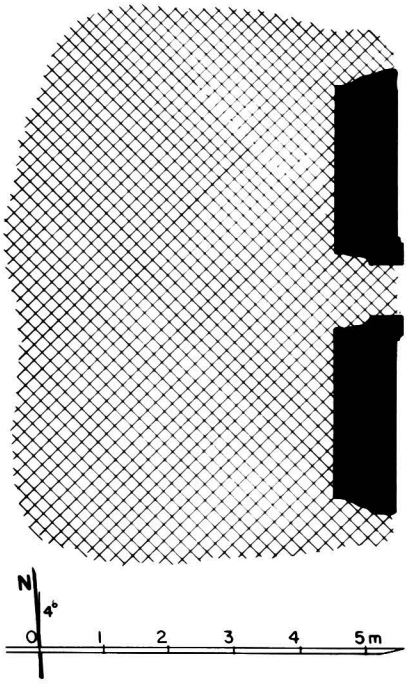
521 a - Plan

5 present condition
- ruined.
- only east wall remains.
- ground floor buried under debris.

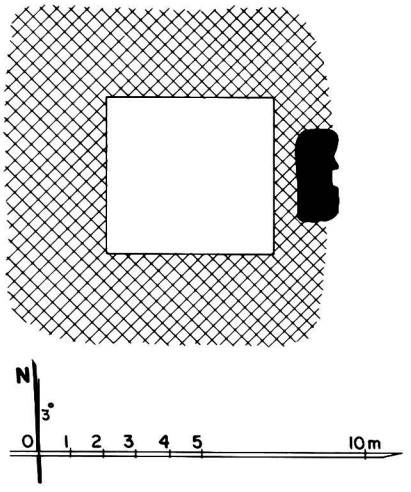
522 a - Plan

5 present condition
- ruined.
- ground floor buried under debris.

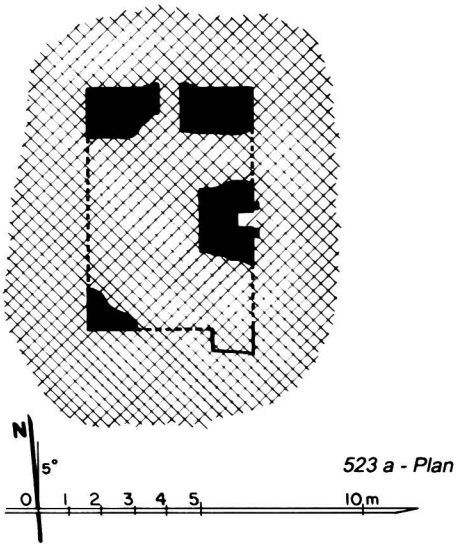
523 a - Plan

5 present condition
- ruined.
- ground floor buried under debris.

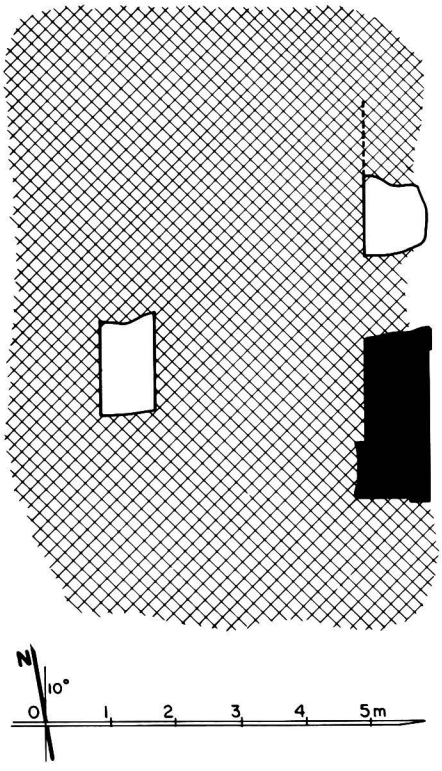
524 a - Plan

5 present condition
- ruined.
- only south-east corner remains.
- ground floor buried under debris.

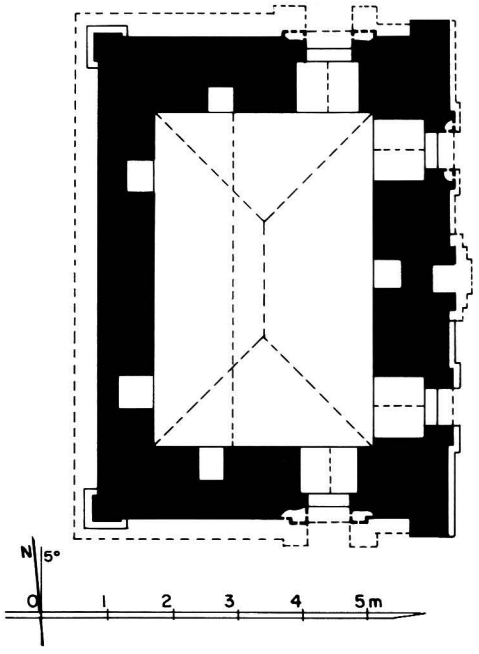
525 a - Plan

5 present condition
- half-ruined.
- base disintegrated.
- north-east corner collapsed under rain on 10-8-1986.

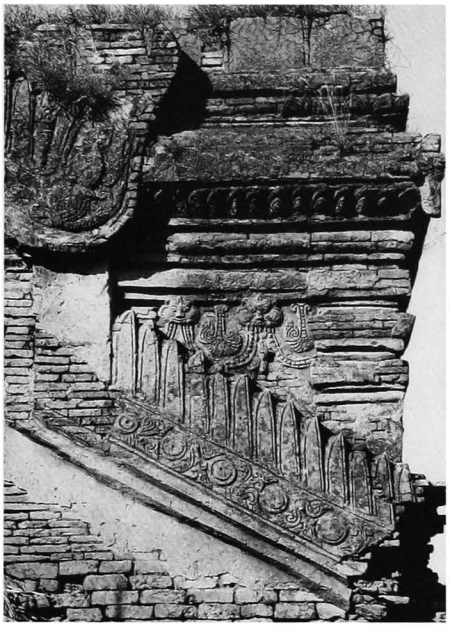
525 e - East face, north-east corner, 13-8-1986

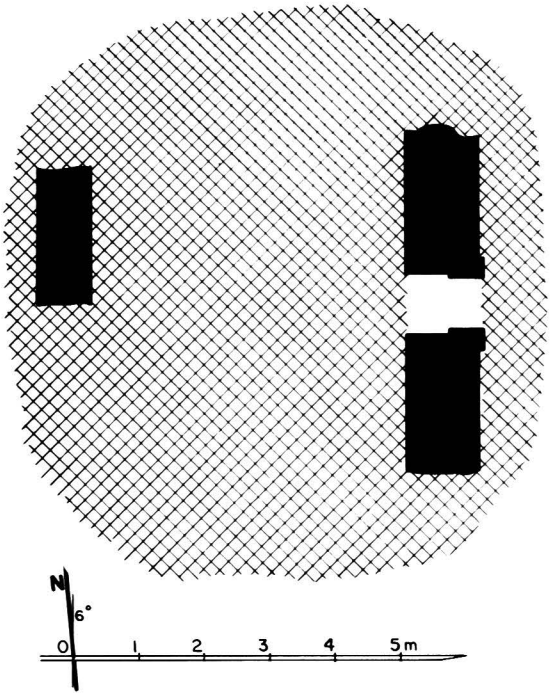
527 a - Plan

5 present condition
- ruined.
- ground floor buried under debris.

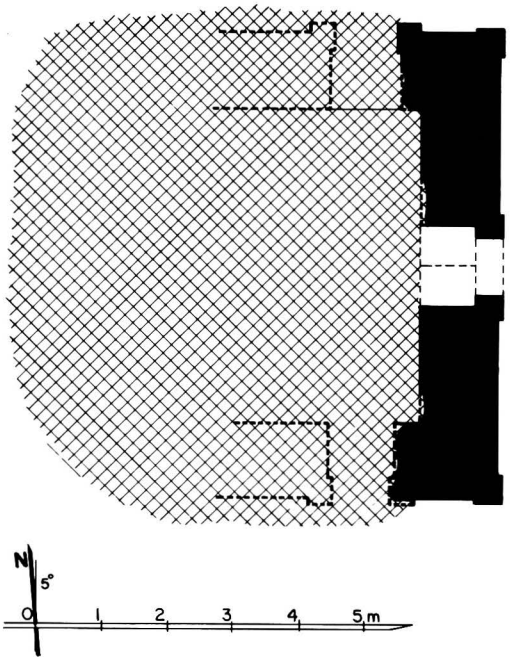
528 a - Plan

5 present condition
- ruined.
- only part of east wall remains.
- ground floor buried under debris.

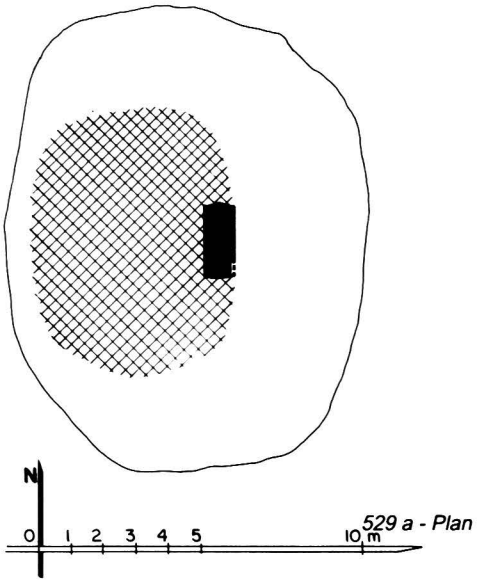
529 a - Plan

5 present condition
- ruined.
- only part of east wall remains.
- ground floor buried under debris.

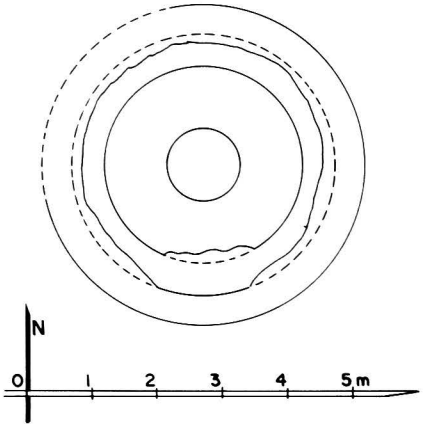
531 a - Plan

5 present condition
- half-ruined.
- base and terraces disintegrated.
- upper parts badly damaged.

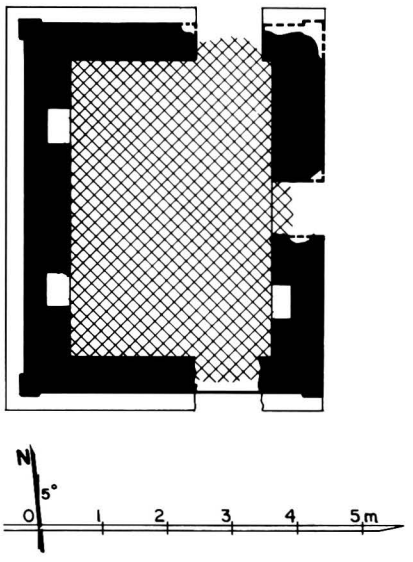
532 a - Plan

5 present condition
- ruined.
- ground floor buried under debris.

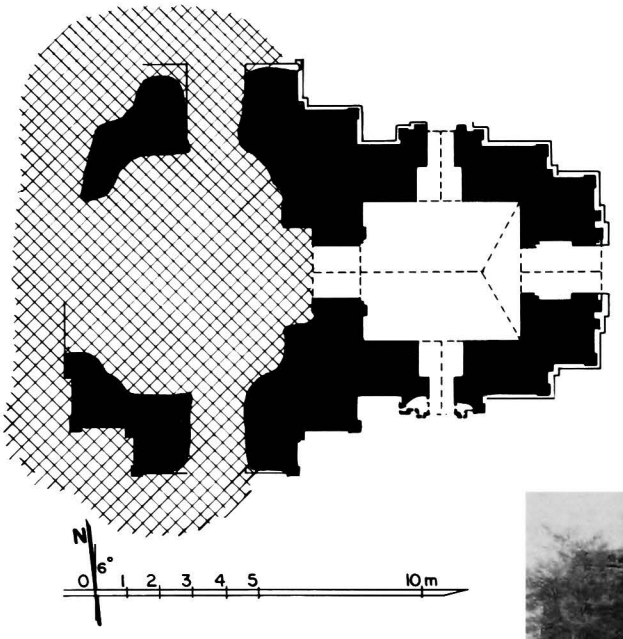
533 a - Plan

5 present condition
- ruined.
- vault of shrine and upper parts collapsed.
- ground floor buried under debris.

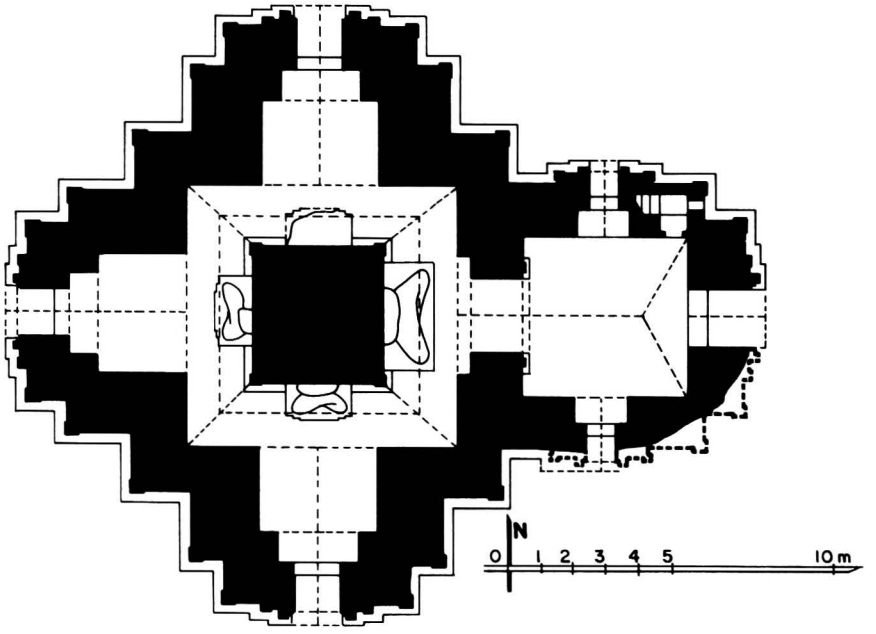
534 a - Plan

5 present condition
- no maintenance.
- vault over entrance hall collapsed with south wall.

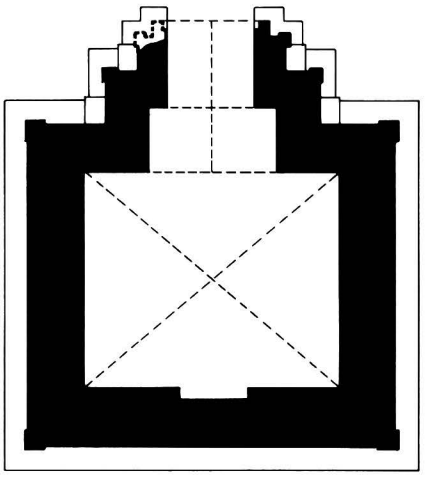
535 a - Plan

5 present condition
- no maintenance.
- structure severely cracked.
- upper parts badly damaged.

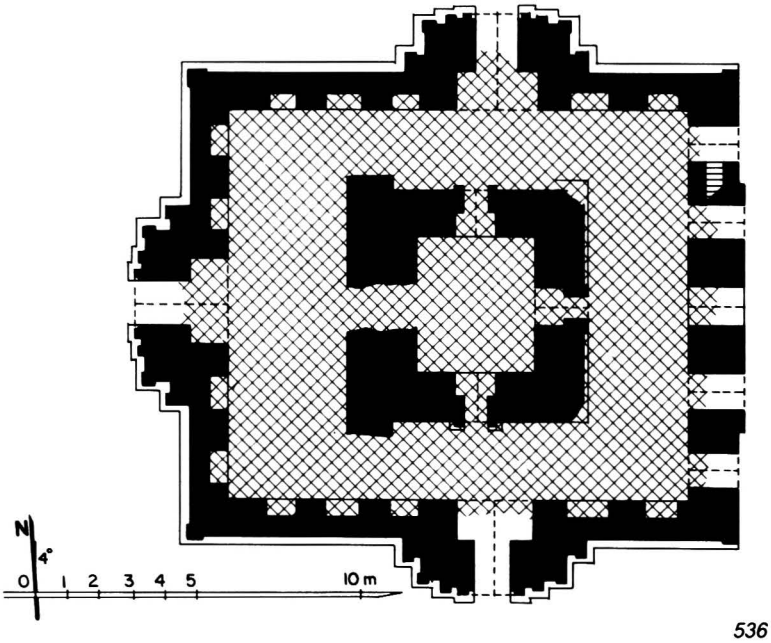
31 Shinbin-yan-pye

5 present condition
- ruined.
- no more trace of vaults.
- ground floor buried under debris.

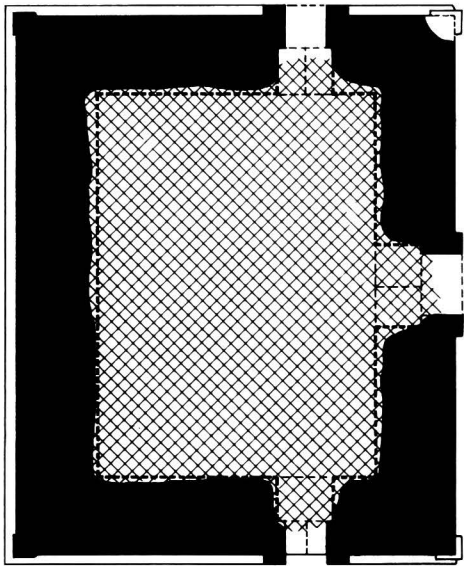
537 a - Plan

5 present condition
- ruined.
- ground floor buried under debris.

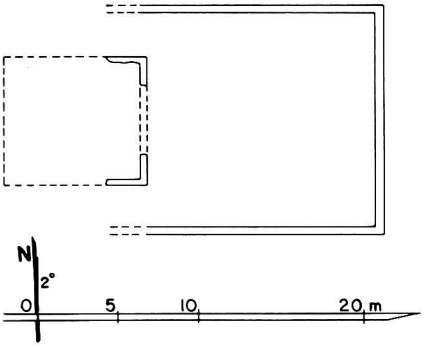
538 a - Plan

5 present condition
- ruined.
- only parts of east wall corners remain.

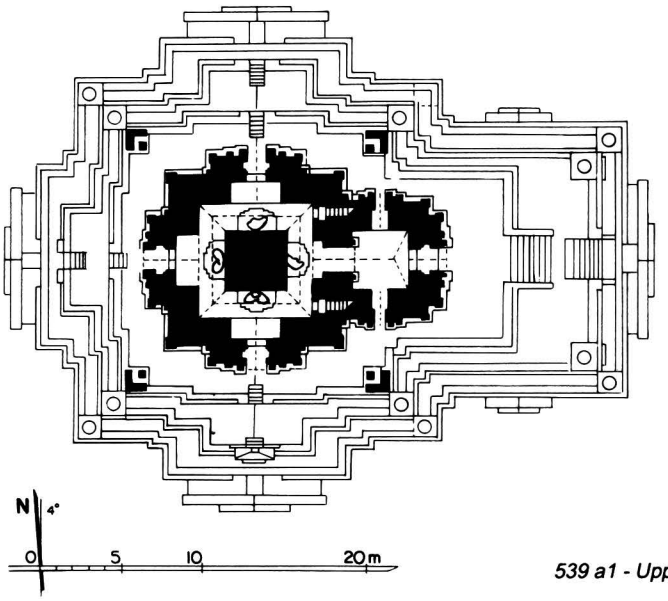
539 a1 - Upper-storey plan

5 present condition
- regularly maintained.
- square tower destroyed.
- repaired 1964-1972 and (Const. Corp.) 1979.
- brick grilles built by Dept.

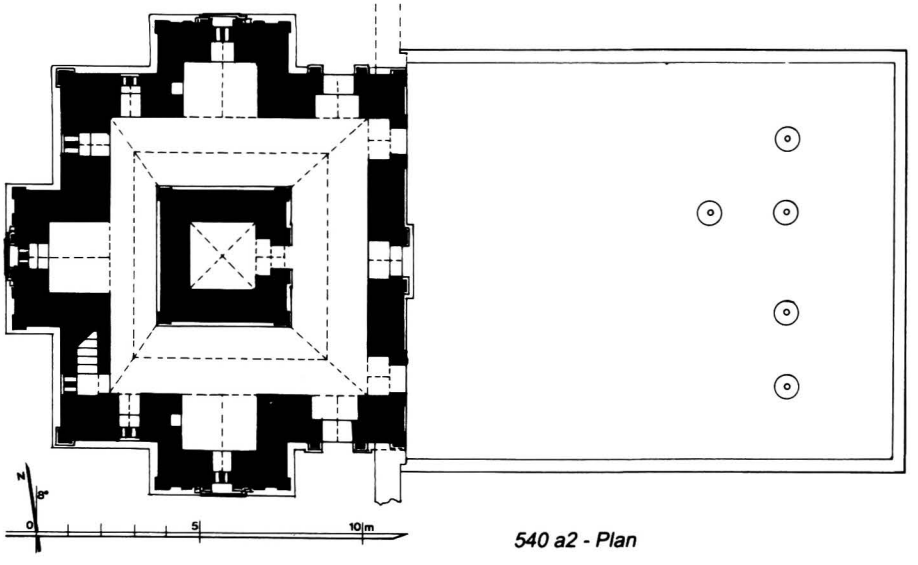
540 a2 - Plan

5 present condition
- no maintenance.
- collapse of vault at north-east and north-west corners.
- structure badly cracked.

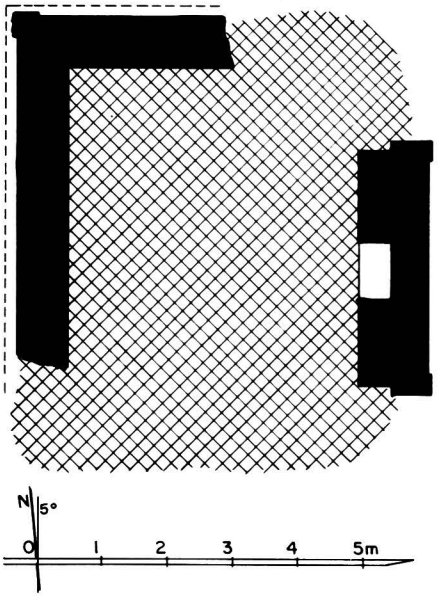
541 a - Plan

5 present condition
- ruined.
- vault and roof collapsed.
- ground floor buried under debris.

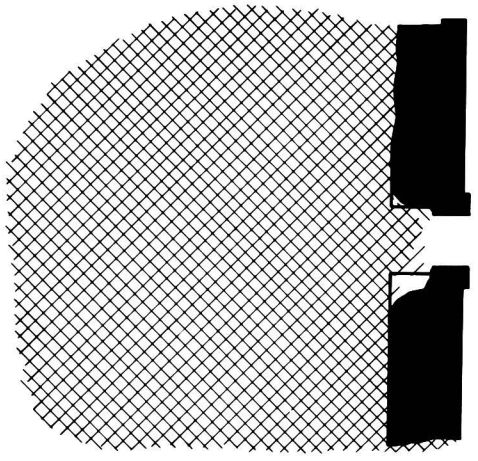
542 a - Plan

5 present condition
- ruined.
- only part of east wall remains.
- vault and roof collapsed.
- ground floor buried under debris.

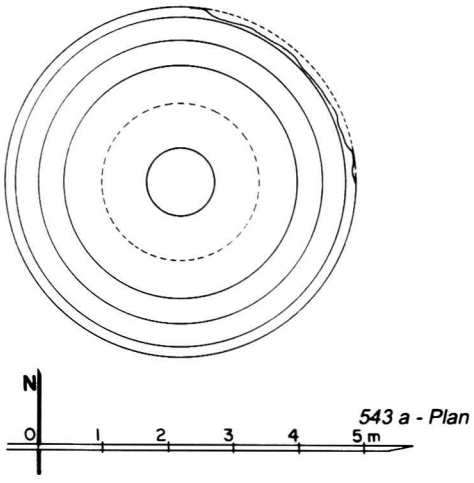
543 a - Plan

5 present condition
- no maintenance.
- base disintegrating.

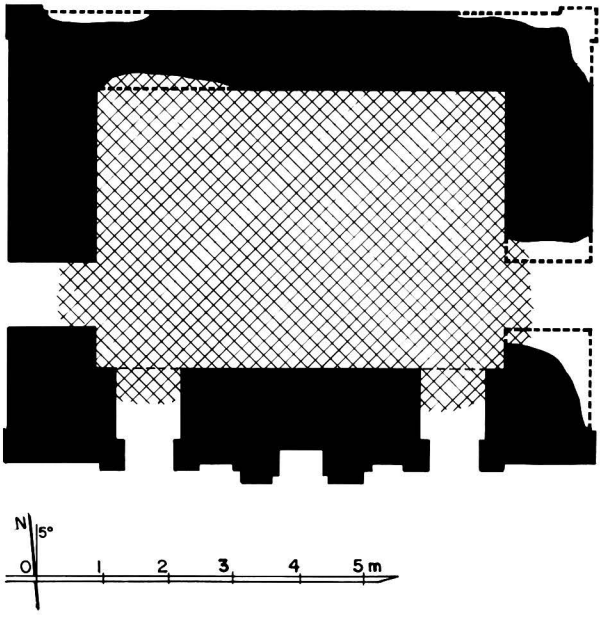
544 a - Plan

5 present condition
- ruined.
- vault and roof collapsed.
- ground floor buried under debris.

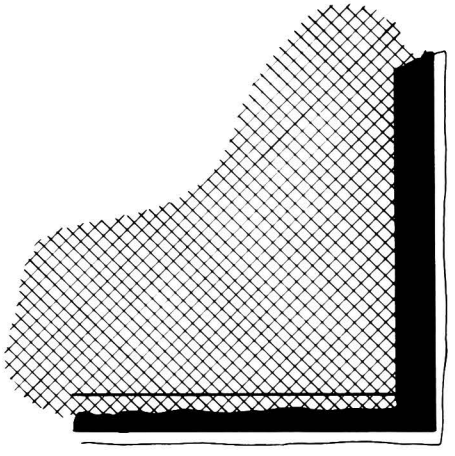
545 a - Plan

5 present condition
- ruined.
- only south-east corner remains.
- vault and roof collapsed.
- ground floor buried under debris.

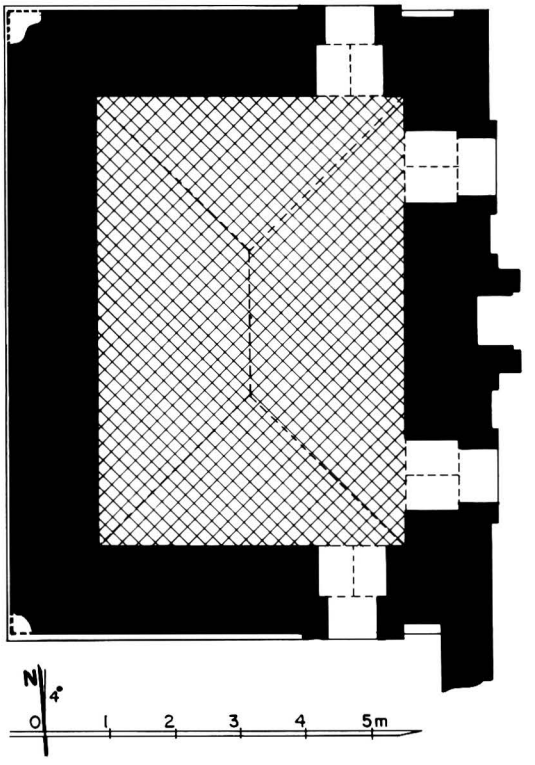
546 a - Plan

5 present condition
- ruined.
- vault and roof collapsed.
- ground floor buried under debris.

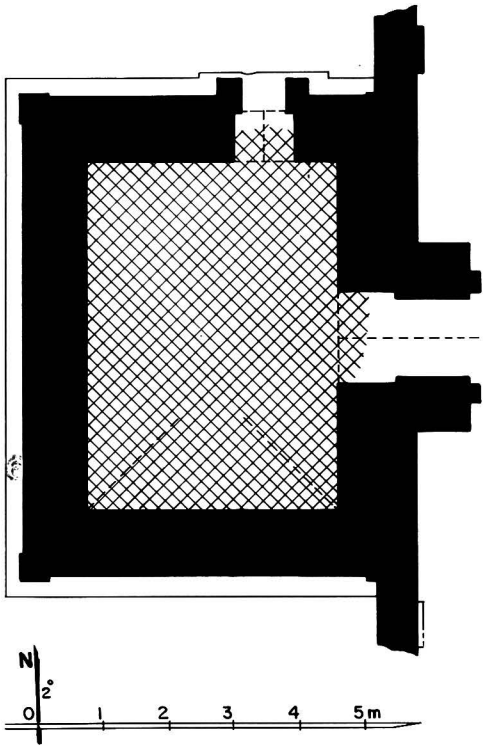
547 a - Plan

5 present condition
- ruined.
- vault and roof collapsed.
- ground floor buried under debris.

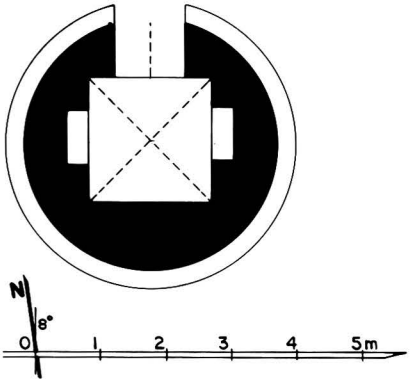
548 a - Plan

5 present condition
- no maintenance.
- half-ruined.
- north porch collapsed.

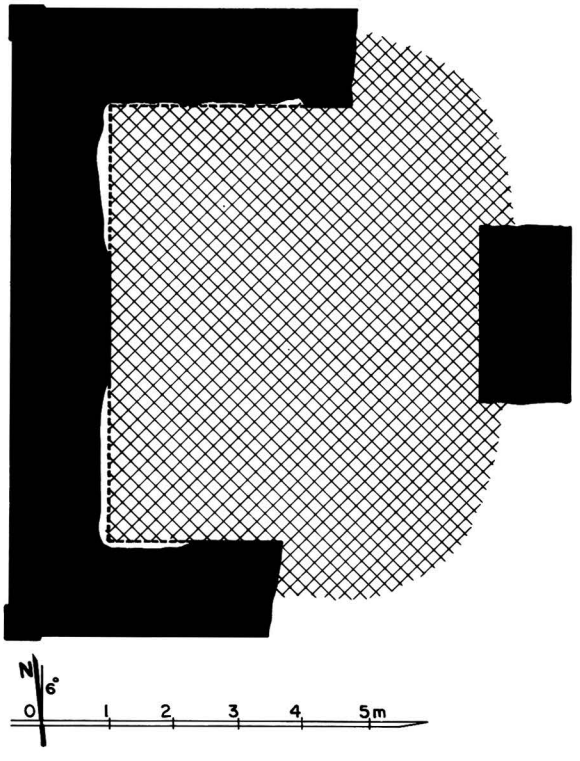
549 a - Plan

5 present condition
- ruined.
- vault and roof collapsed.
- ground floor buried under debris.

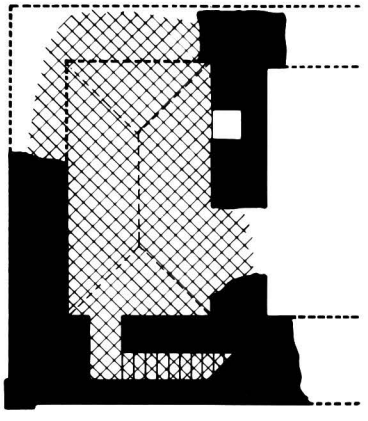
550 a - Plan

5 present condition
- ruined.
- vault and roof collapsed.
- ground floor buried under debris.

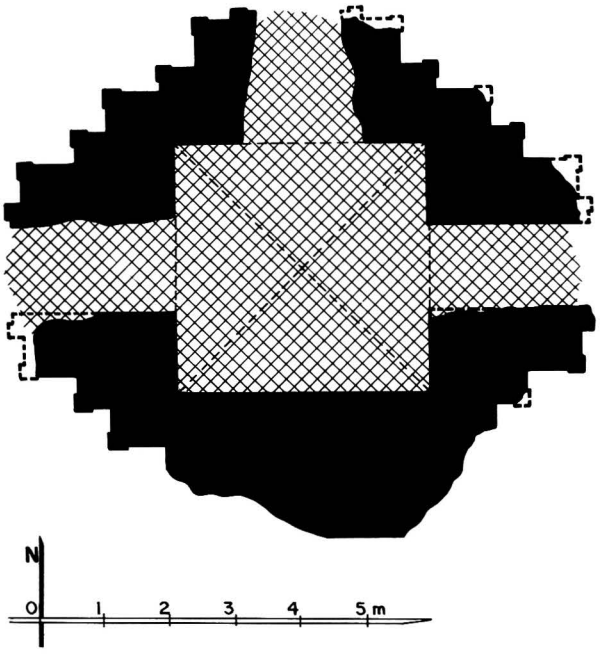
551 a - Plan

5 present condition
- ruined.
- vaults and upper parts collapsed.
- ground floor buried under debris.

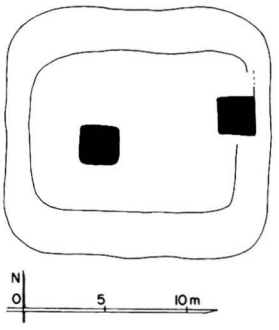
553 a - Plan

5 present condition
- brick debris and stone plinth.
- height: approx. 2.10 m.

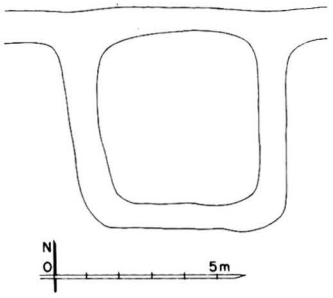
554 a - Plan

5 present condition
- brick debris.
- height: approx. 0.60 m.

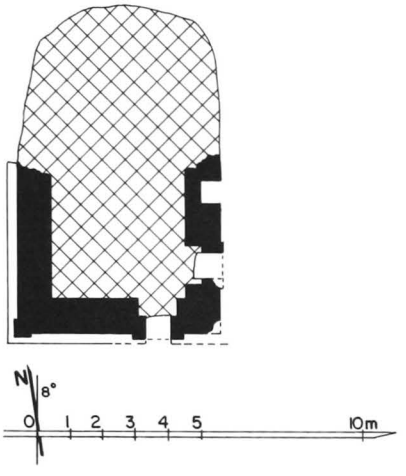
556 a - Plan

5 present condition
- ruined.
- ground floor buried under debris.

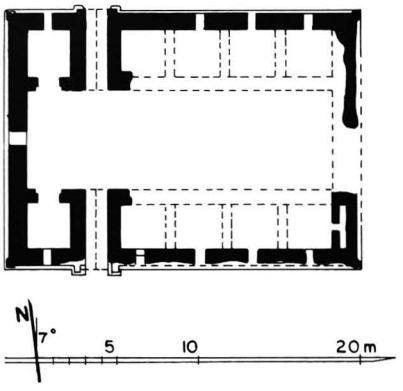
559 a - Plan

5 present condition
- ruined.
- vaults and upper parts collapsed.
- ground floor buried under debris.

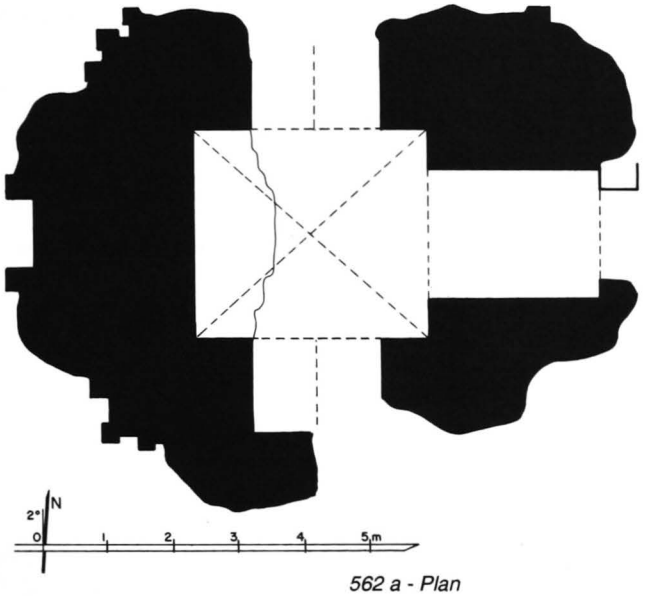
562 a - Plan

5 present condition
- no maintenance.
- half-ruined.
- base disintegrated.
- upper parts badly damaged.

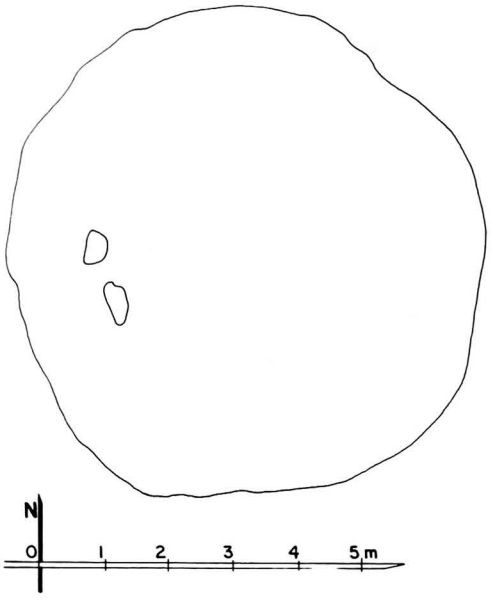
563 a - Plan

5 present condition
- brick and stone debris.
- fragment of a stone image, right knee and hand of a seated Buddha, length: 0.74 m.
- height: approx. 1.10 m.

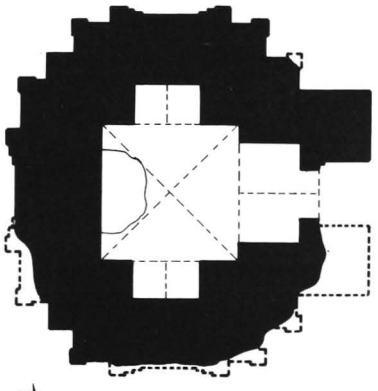
567 a - Plan

5 present condition
- no maintenance.
- east porch collapsed.
- upper parts nearly destroyed.

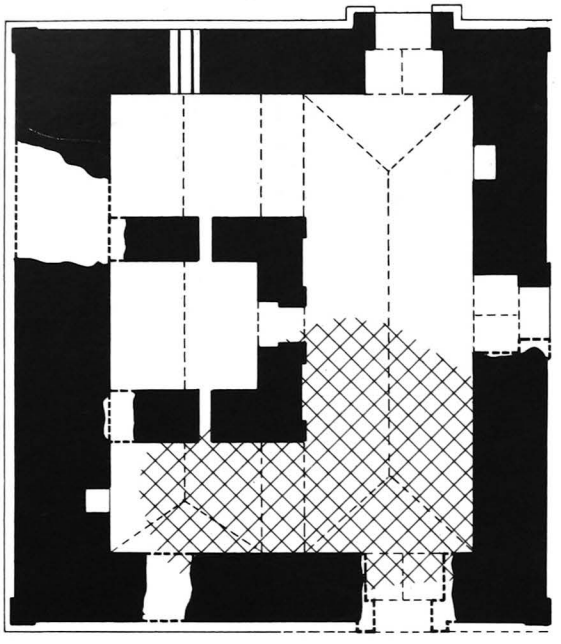
570 a - Plan

5 present condition
- half-ruined.
- vaults collapsed.

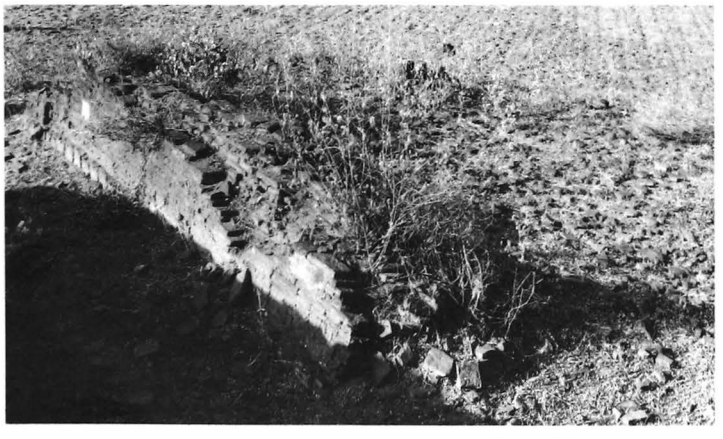
574 b - Enclosure wall, west face, south-west corner, from west

5 present condition
- brick and stone debris.
- only part of a west wall remaining.
- height: approx. 1.20 m.

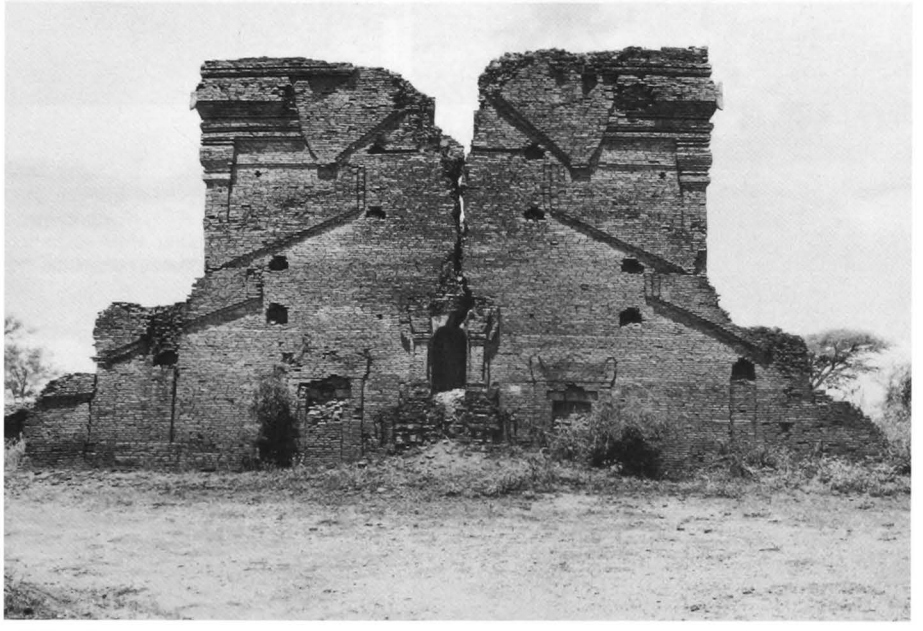
579 b - East face

5 present condition
- ruined.
- vaults collapsed.
- ground floor buried under debris.

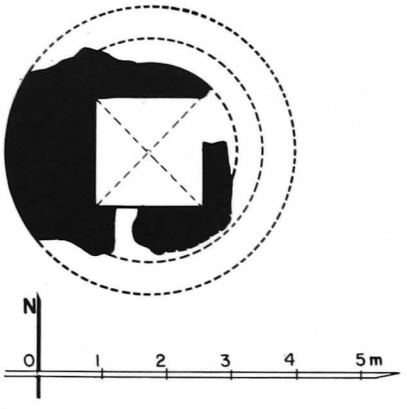
581 a - Plan

5 present condition
- terrace repaired (Arch. Dept.) 1986.

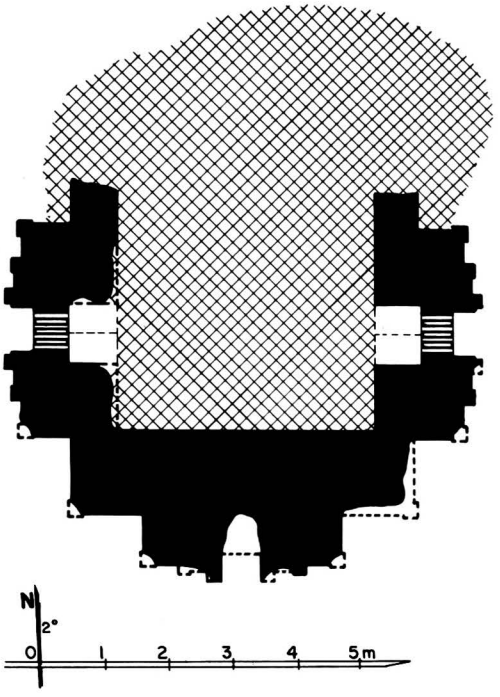
582 a - Plan

5 present condition
- ruined.
- vaults and upper parts collapsed.
- ground floor buried under debris.

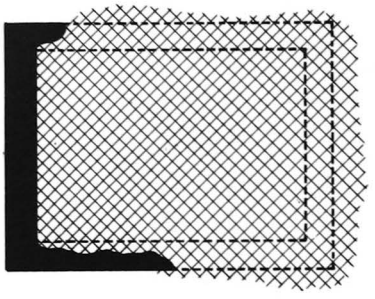
584 a - Plan

5 present condition
- ruined.
- east part, vaults and roof collapsed.
- ground floor buried under debris.

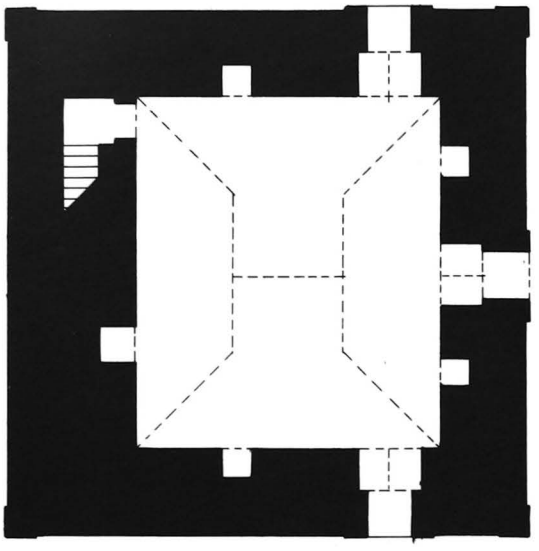
589 a - Plan

5 present condition
- half-ruined.
- vault of upper storey and roof collapsed.

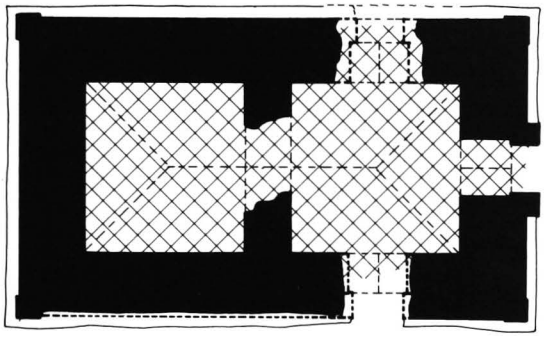
590 a - Plan

5 present condition
- ruined.
- vaults collapsed.
- ground floor buried under debris.

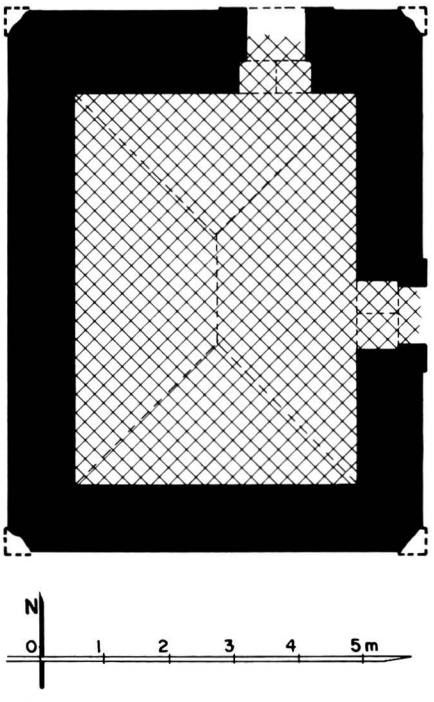
592 a - Plan

5 present condition
- ruined.
- vaults collapsed.
- ground floor buried under debris.

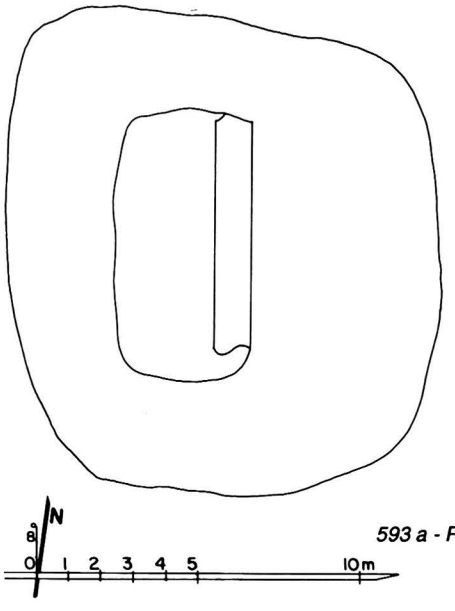
593 a - Plan

5 present condition
- brick debris, average brick: 32 x 16 x 4 cm.
- only part of a wall remaining.
- height: approx. 2.20 m.

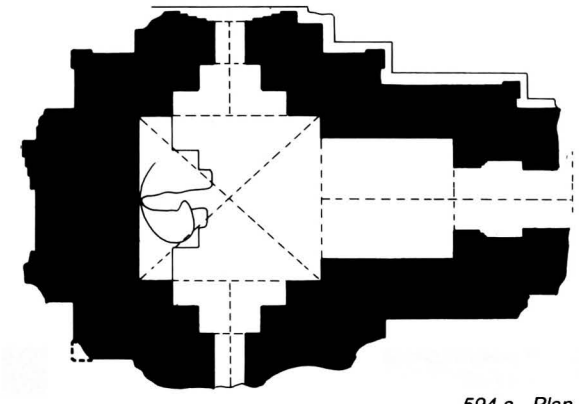
594 a - Plan

5 present condition
- half-ruined.
- base and facing disintegrated.
- upper parts badly damaged and endangered.

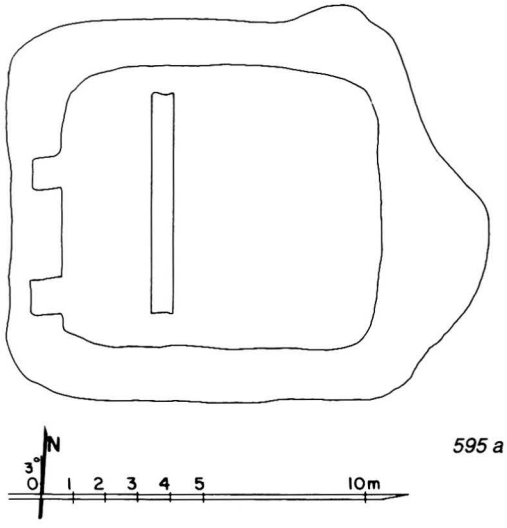
595 a - Plan

5 present condition
- ruined.
- only west wall remains.
- no more trace of vaults.
- ground floor buried under debris.

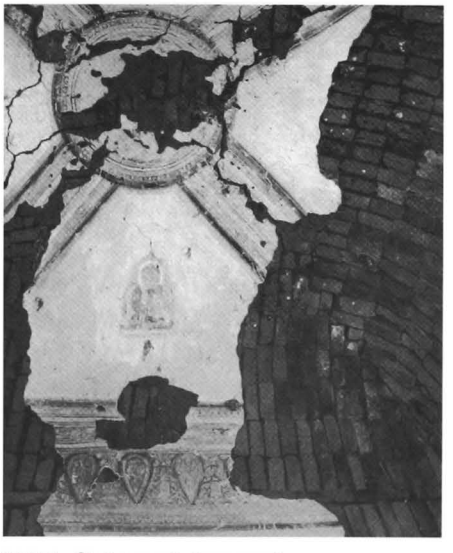
596 d - Shrine vault, from west

5 present condition
- no maintenance.
- upper parts badly damaged.

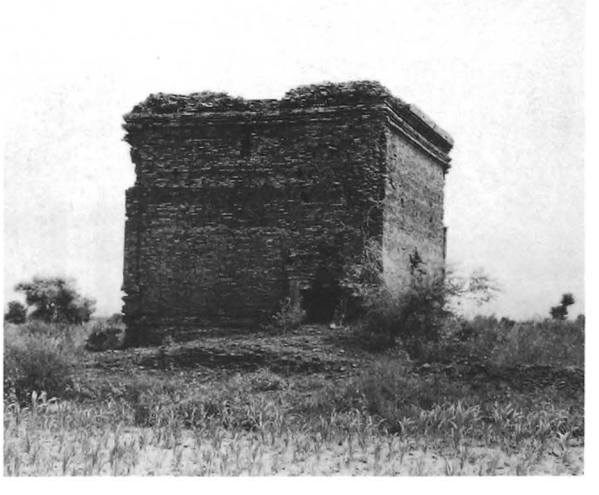
598 b - South face, from south-east

5 present condition
- half-ruined.
- vaults partly collapsed.
- ground floor partly buried under debris.

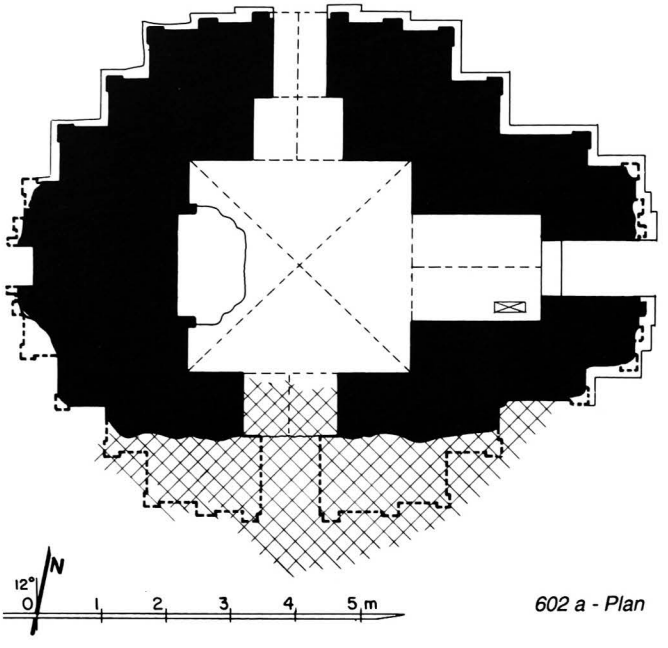
602 a - Plan

5 present condition
- ruined.
- south wall collapsed.
- vaults partly collapsed.
- upper parts collapsed.

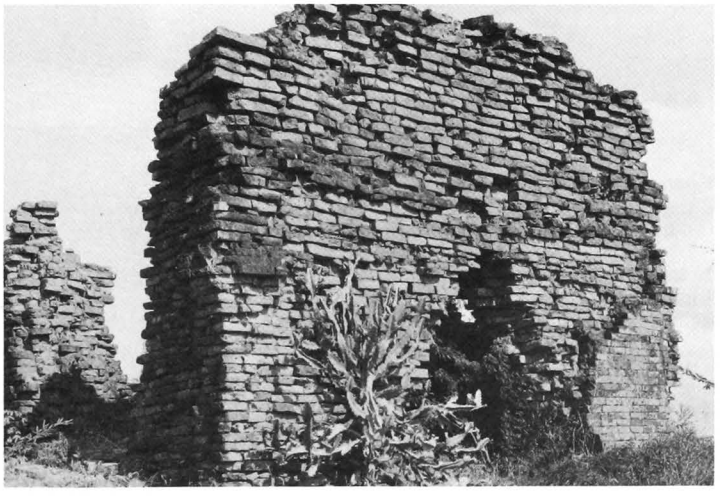
604 c - From south-east

5 present condition
- ruined.
- no more trace of vaults.

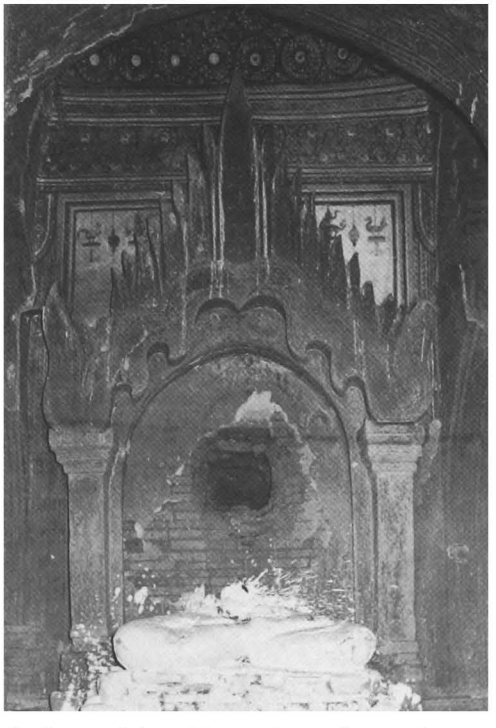
607 k - North-west shrine, niche and image, from north-west

6 images
- 5 seated Buddhas (headless and badly damaged).

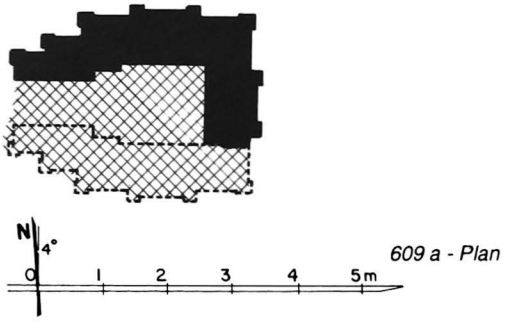
609 a - Plan

5 present condition
- ruined.
- south wall, vaults and upper parts collapsed.
- ground floor buried under debris.

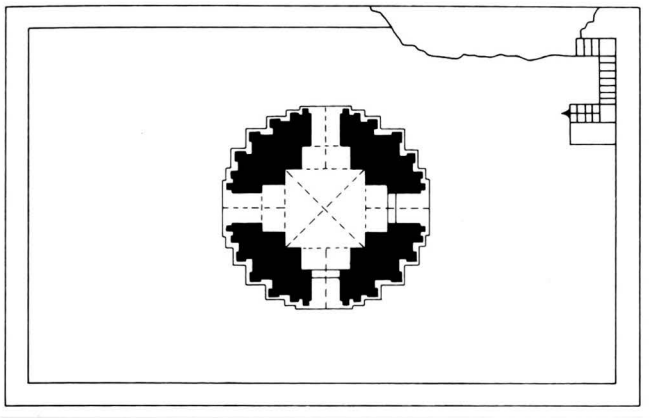
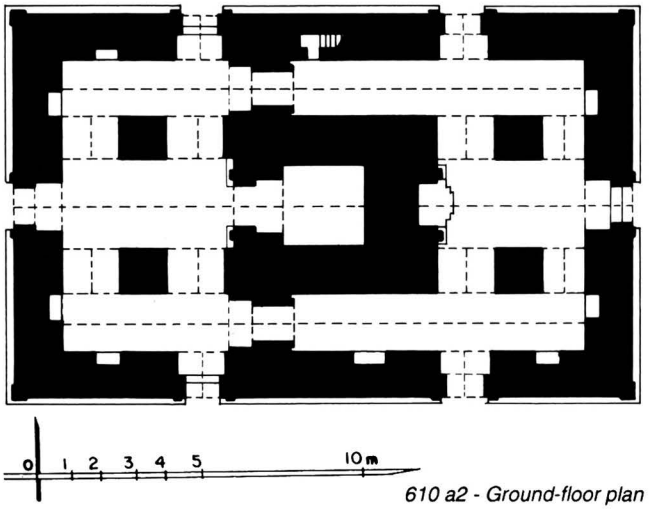
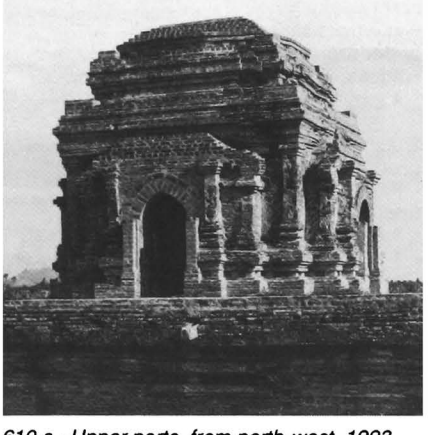
610 a1 - Upper-storey plan

5 present condition
- repaired 1973.
- vault and upper parts of upper storey destroyed by the 1975 earthquake.
- repaired (Const. Corp.) 1986.

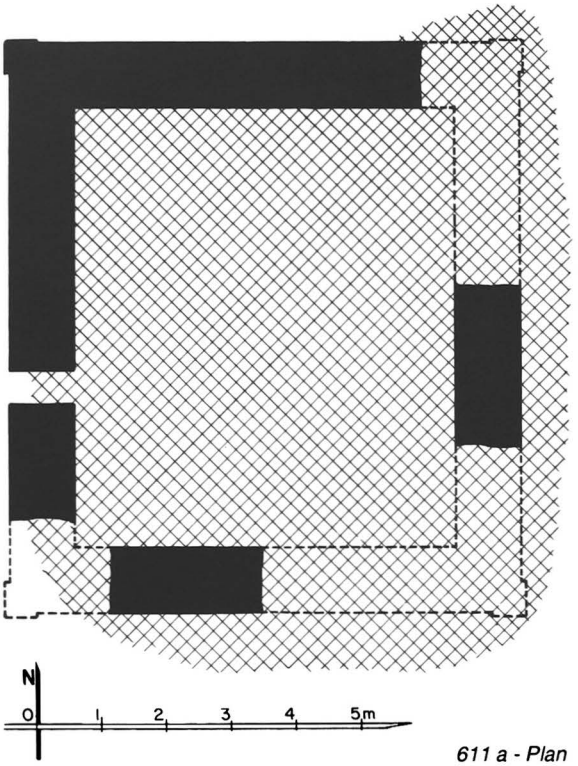
611 a - Plan

5 present condition
- ruined.
- vaults collapsed.
- ground floor buried under debris.

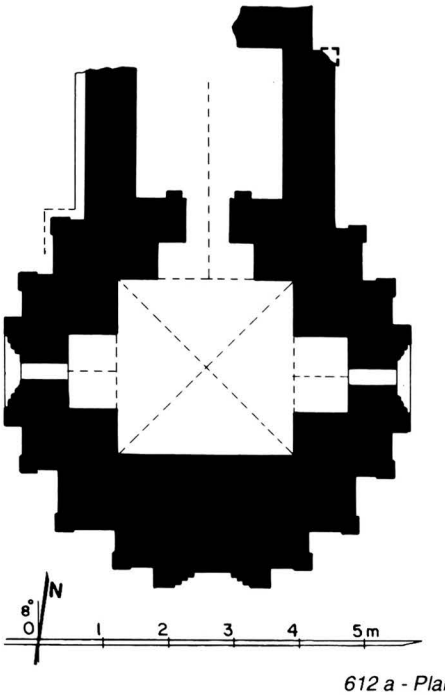
612 a - Plan

5 present condition
- ruined.
- base disintegrated.
- east porch collapsed.
- vaults and upper parts collapsed.
- ground floor buried under debris.
